UNITED STATES ENVIRONMENTAL PROTECTION AGENCY  
REGION II

SUBJECT: Removal Site Evaluation for the Matteo Iron and Metal Site, West Deptford, Gloucester County,  
New Jersey

FROM: Nick Magriples, On-Scene Coordinator  
Removal Action Branch

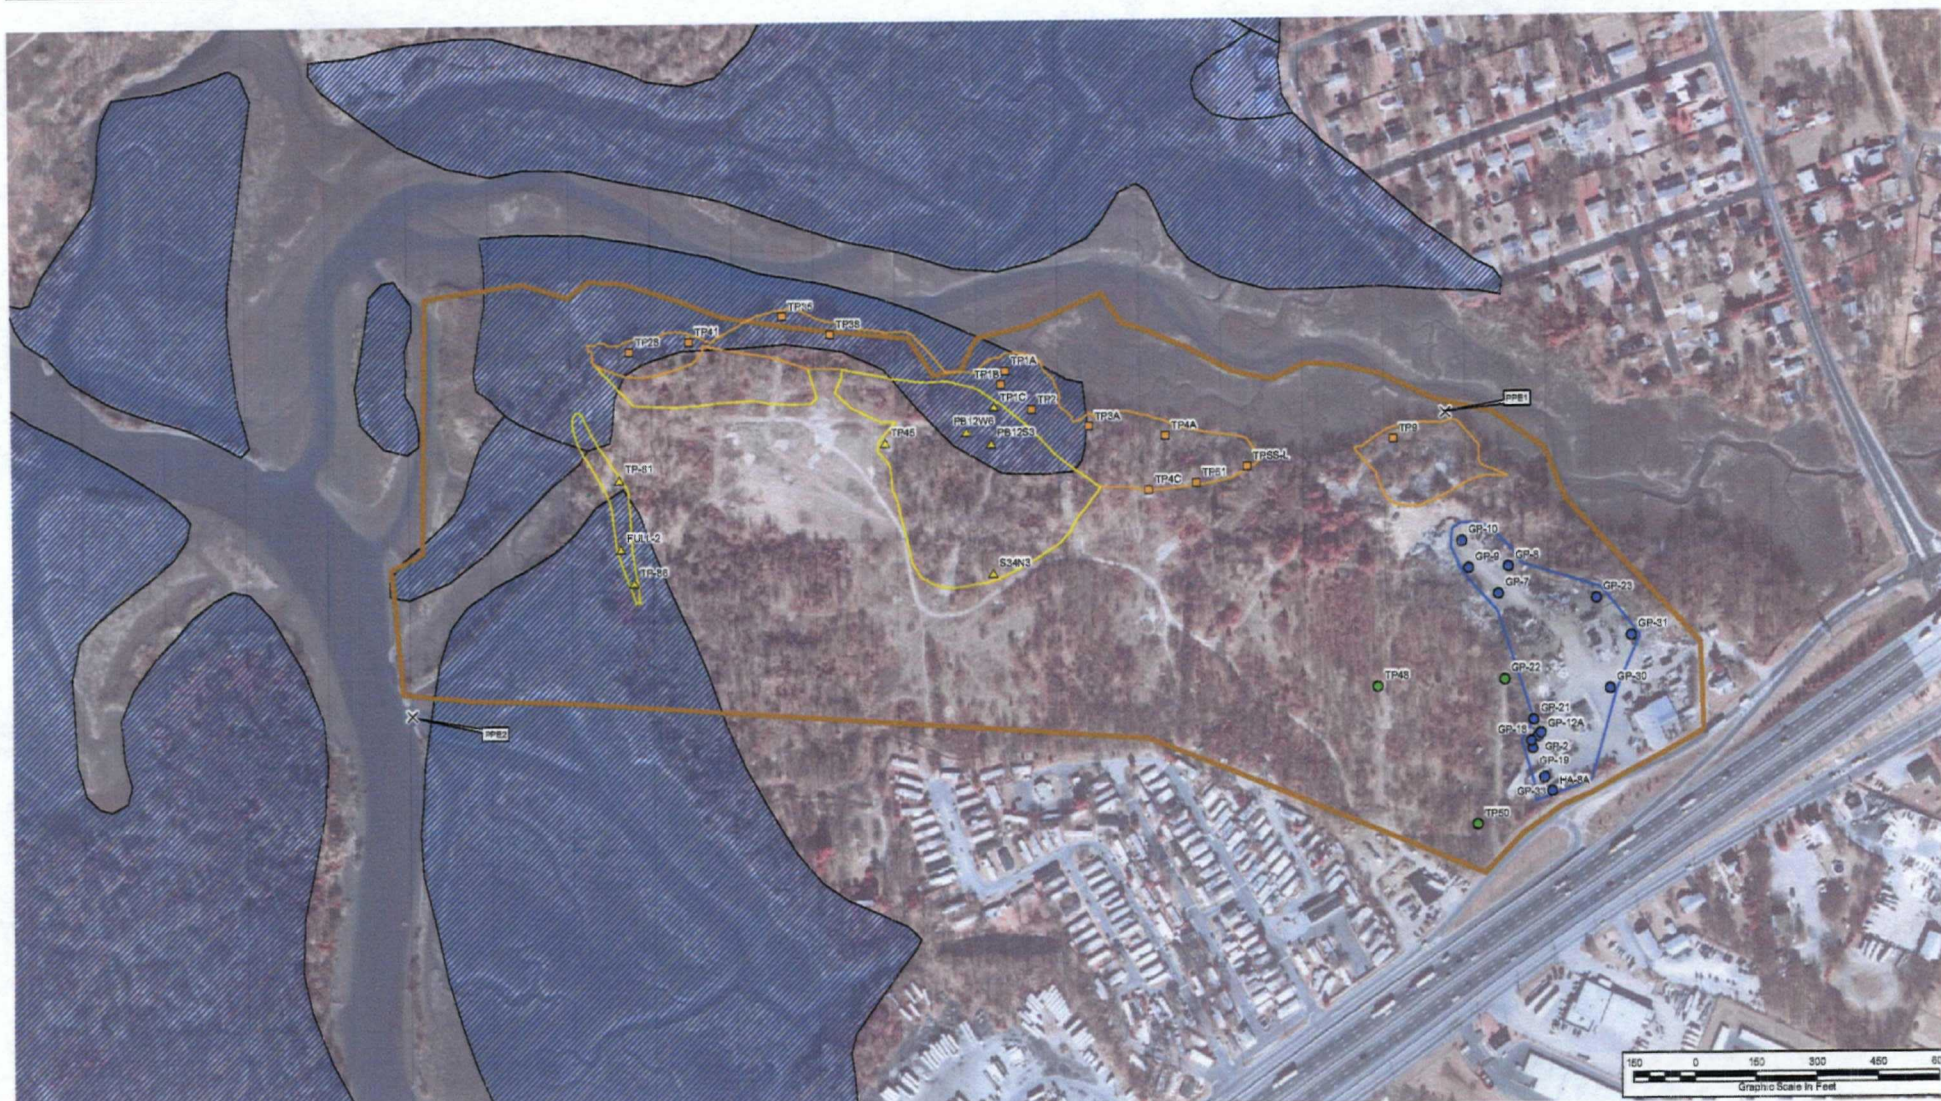
**Figure 2**

- Pile Samples
- Landfill Samples
- Contaminated Soil Samples
- Background Samples
- Probable Point of Entry
- Approximate Boundary of Matteo Property

Source 1: Battery Casing Waste Pile

Source 2: Inactive Landfill

Source 3: Contaminated Soil

Figure 2  
 Source Location Map  
 Matteo and Sons, Inc.  
 Thorofare, Gloucester County, NJ

The Site is situated in the Woodbury-Hessian Run marshes, which are freshwater tidal marshlands (see Figure 2). Woodbury Creek has one of the largest remaining tidal freshwater wetlands on the Delaware River. The tidal marshes are flat and regularly flooded by slightly brackish tides. These marshes are considered to be part of the Delaware River Estuary. Both the NJDEP Freshwater Wetland Map and the National Wetland Inventory (NWI) Mapping identify wetland habitats in and around the Site. The tidal reach of the Delaware River is part of the National Estuary Program, a program set up to protect estuarine systems of national significance.

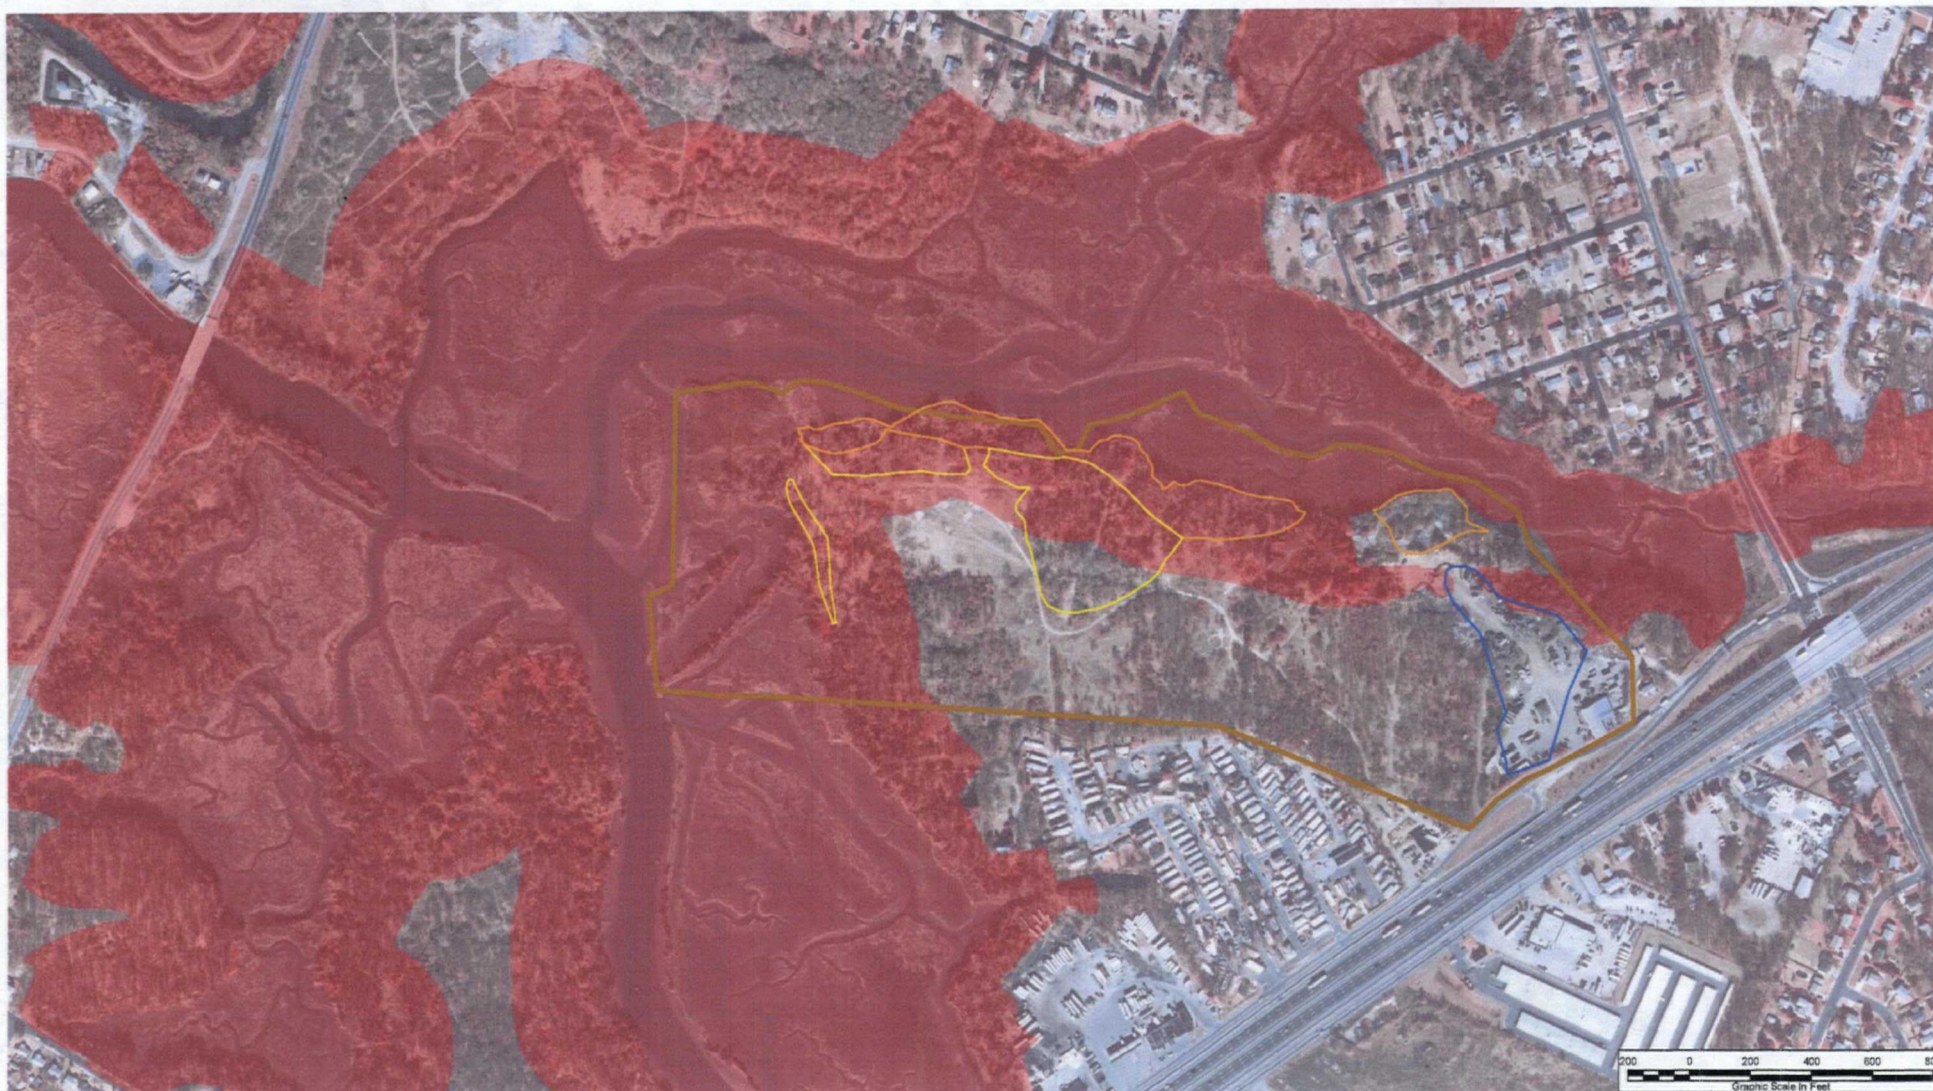
**Figure 3**

- Bald Eagle Foraging Location
- Source 1: Battery Casing Waste Pile
- Source 2: Inactive Landfill
- Source 3: Contaminated Soil
- Approximate Boundary of Matteo Property

<p>Figure 3 Bald Eagle Foraging Location Map Matteo and Sons, Inc. Thorofare, Gloucester County, NJ</p>		
FIGURE	SCALE	DATE
4	1:2,400	JUNE 2005

Program, the northern and western portions of the Site and the Woodbury-Hessian Run marshes are considered foraging locations for the bald eagle (see Figure 3). The bald eagle is listed by the U.S. Fish and Wildlife Service as threatened. The NJDEP Division of Fish and Wildlife considers the bald eagle breeding population as endangered and their non-breeding population as threatened.

Based on test pits conducted during an NJDEP field investigation, the volume of waste material landfilled at the Site is estimated to be 80,000 cubic yards (see Figure 3). Of this total, approximately 23,000 cubic yards consists of battery casings, 22,000 cubic yards of battery casings mixed with general waste, and 35,000 cubic yards of general waste. It is estimated that there are an additional 7,000 cubic yards of battery casings in the sediments of Hessian Run to a depth of three feet, as measured 20 feet from the south bank. Not including the area covered by the battery casings in the sediments of Hessian Run, there are approximately 10,500 cubic yards of sediments to a depth of one foot with contamination greater than the NJDEP SEL Sediment Quality Criteria and approximately 99,500 cubic yards of sediments to a depth of three feet with contamination greater than the SEL. The volume of soil contamination (not including the battery casings) identified above NJDEP Residential Direct Contact Soil Cleanup Criteria (RDCSCC) across the entire Site is estimated to be 58,000 cubic yards.
